## Oroville Dam, ICOLD President intervenes on the radio

By Michael Rogers and Emmanuel Grenier

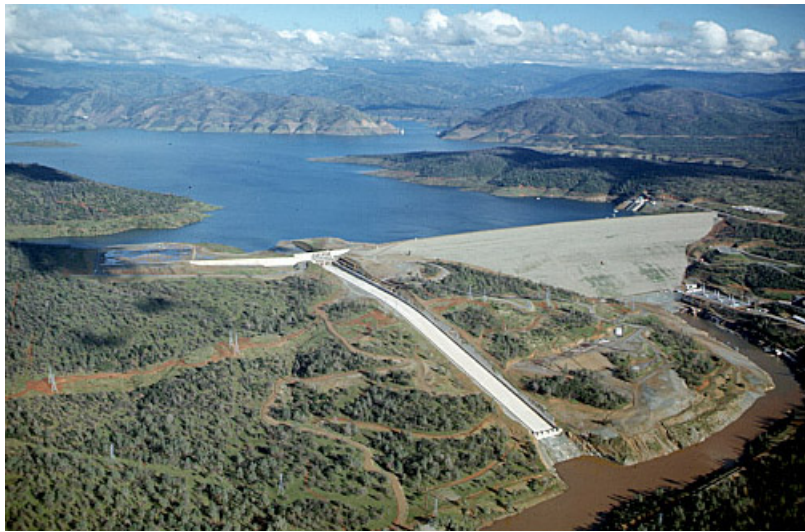
Aerial View of the Oroville Dam (photo by California Department of Water Resources)

There is now a rush to repair the spillways at the [Oroville Dam in Northern California](#) and lower the water level in Lake Oroville before rain arrives again. It is feared that damage to an emergency spillway could dump large amounts of water into the Feather River, which runs through downtown Oroville. This fear led to the evacuation of nearly 200 000 people living under the lake. The main dam (235m high) was never in danger and remains safe. The Oroville Dam issue started with an unexplained structural failure of a lower part of the 3000-foot-long gated service spillway.

On February 11, water flowing over the emergency spillway discharged down an unlined hillside area, which unexpectedly started to erode very deeply, head-cutting its way back up towards the concrete spillway weir.

Once this unexpected situation was identified, DWR re-opened the service spillway gates fully and accepted continued loss of the lower concrete portion of the service spillway in order to quickly lower the reservoir level below the crest of the emergency spillway. The DWR also initiated its emergency action plan when the unexpected scour was observed at the emergency spillway just in case that section failed. Almost 200,000 persons have been reported to have evacuated the downstream areas.
